## **Biomass accident investigations – missed opportunities for learning and accident prevention**

**Hedlund, Frank Huess**

Proceedings of the 25th European Biomass Conference and Exhibition

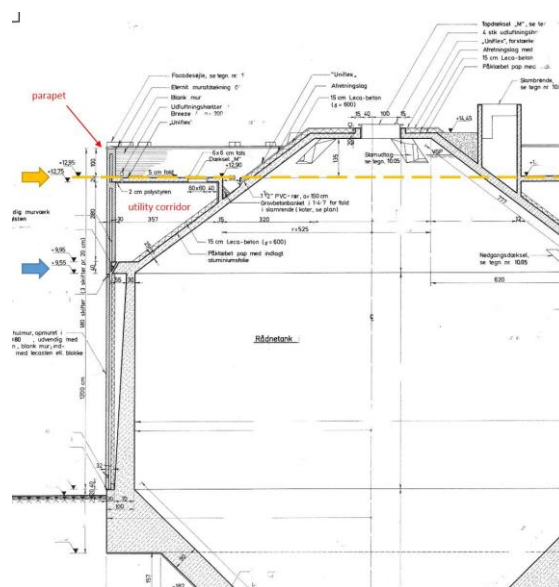
**Figure 1:** Part of cross-sectional drawing of the accident biogas digester. The blue arrow marks the horizontal ring beam. The yellow arrow and dotted line mark the roof deck supported by a parapet. Five contractors were present at the roof doing asphalt roofing work when the explosion took place. Drawing courtesy of Krüger, Denmark.

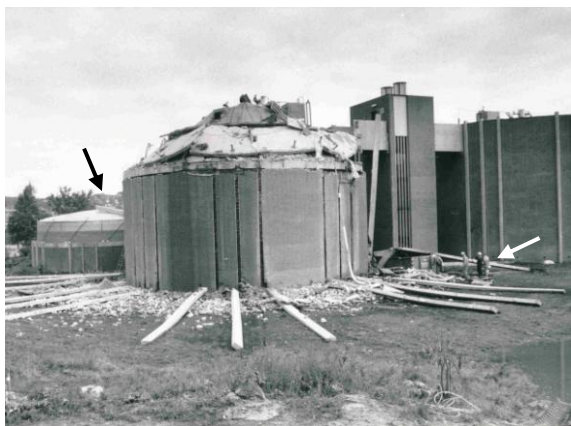
**Figure 2:** Aftermath. The accident Digester #4 center, the identical and apparently undamaged digester #3 to the right. The digester's roof deck collapsed and two roofing contractors fell down 11 m. At least one of the decorative concrete columns fell onto the gasholder tank behind the accident digester at center left (arrow).. Note persons for scale at center right (arrow). Photo courtesy of Vejle Amts Folkeblad.

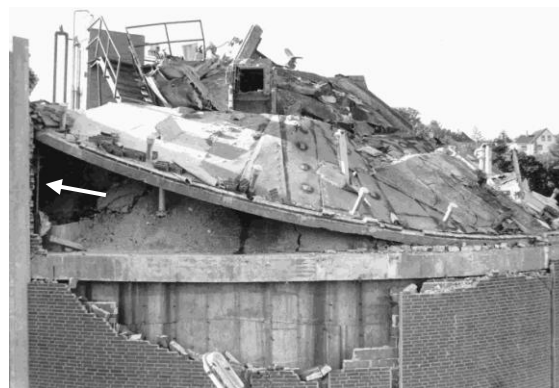
**Figure 3:** The collapsed roof deck. A small section of the remains of the parapet, which provided structural support to the roof deck, is just visible to the left (arrow). Photo courtesy of Vejle Amts Folkeblad.

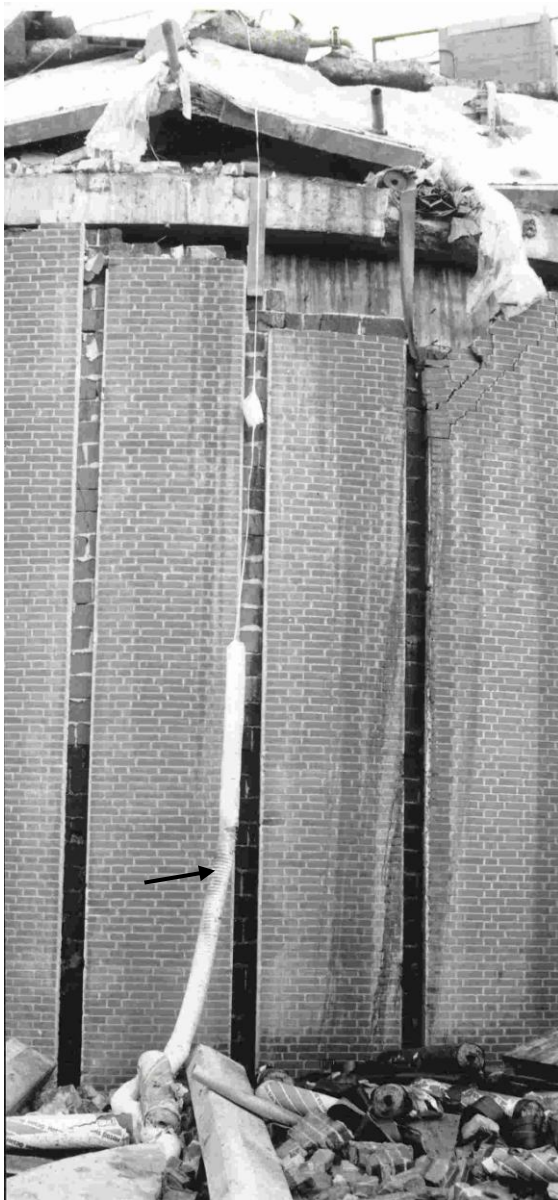
The investigation soon identified the cause. The hose fitted to the digester's 8" top vent valve was a simple flexible duct similar to those commonly used for household kitchen ventilation purposes – a plastic cover over a metal wire coil to shape a tube (Fig. 4). The hose did indeed terminate at the perimeter of the digester and was indeed elevated to a height of 3 m, but the hose was lying on the roof, unprotected. In a moment of inattention, a worker had grazed the flexible hose with his propane burner torch – the plastic had melted and the gas inside ignited. There was no flashback arrestor in the line and the flame could travel back into the digester, causing an explosion there.

**Figure 4:** The "glaringly obvious hazard" (with the benefit of hindsight). The standard flexible duct of the same type commonly used for household kitchen ventilation purposes hangs from the roof (arrow), torn and burnt. It was fitted to the top valve to vent excess digester gas. The propane torch of an asphalt roofing contractor grazed the flexible duct, ignited the gas inside, and the flame flashed back into the digester, leading to explosion. Photo courtesy of Vejle Amts Folkeblad.

Mistakes in execution are also evident. The decision to use a standard flexible duct similar to those commonly used for household kitchen ventilation purposes is disturbing as is the practical implementation, with the hose lying directly on the roof, unprotected. The asphalt roofing contractors seem to have been clueless about hazards.

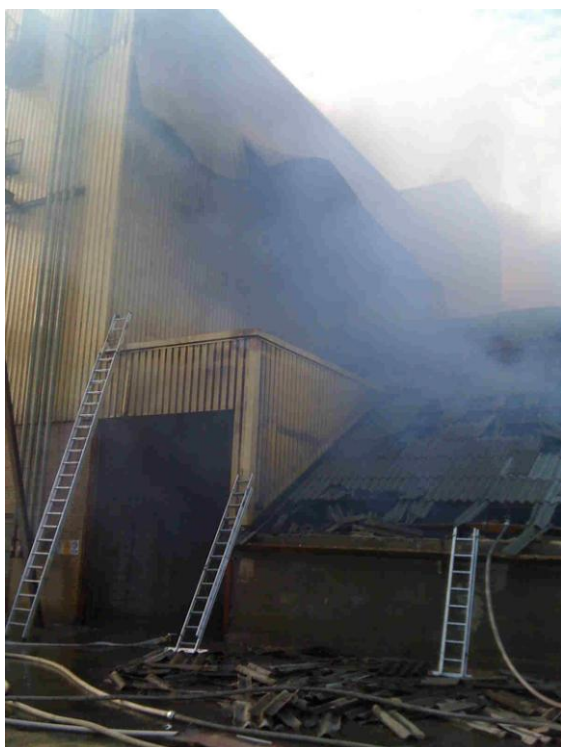
On September 16, 2010, the facility experienced a new explosion, in the same building, and almost at the same location, when a Volvo wheel loader grabbed a bucket of wood dust in a storage bay. Within seconds, the floor in the bay was on fire and the flames almost instantly expanded to fill the entire compartment. The fire then triggered a dust explosion, which damaged the roof and blew out wall panels. The intense fireball killed the driver of the wheel loader. Another worker present inside the building was injured. The building was a complete loss (Fig. 5).

**Figure 5:** Light damage. The many fiber cement roofing panels and wall panels that remained in place indicate that the dust explosion overpressure was modest. The dust explosion severity certainly could have been worse. Photo courtesy of Beredskab Vesthimmerland.

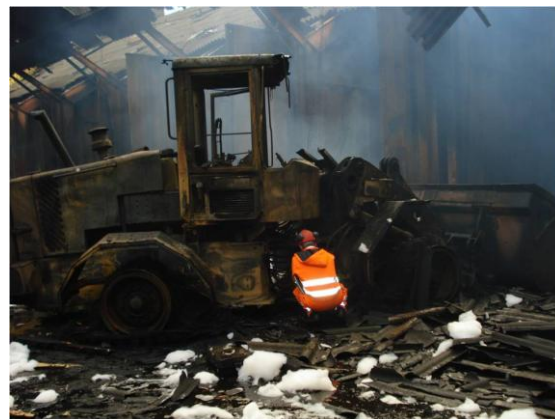
Already the following day, the police informed the public that the cause of the explosion was identified. Due to a weld failure, the universal (cardan) joint, a power transmission component, broke loose under the vehicle and damaged nearby electrical cables. Electrical shorts and arching ignited airborne dust, which resulted in a combustible dust explosion, concluded the police [28].

**Figure 6:** Superficial investigation. A specialist police vehicle inspector examines the accident Volvo wheel loader shortly after the dust explosion. Tires are burned away and windows in the cabin melted. Upon learning that the universal (cardan) joint had failed, he erroneously concluded the explosion was caused by a mechanical failure due to a concealed weld defect. This finding closed the police investigation, as there was no indication of wrongdoing, only of bad luck. The inspector is looking in the wrong place for causes however. In fact, the underlying cause are in the storage bays just visible in the background. Why design the wood pellet facility with a buffer storage of 500 t of combustible wood dust? It was convenient to store the dust, but not essential to do so. Had the ATEX safety principles been applied, the buffer storage, and hence the fuel source and the potential for severe dust explosions, would have been eliminated. Source: Police investigation and the Danish Working Environment Authority.

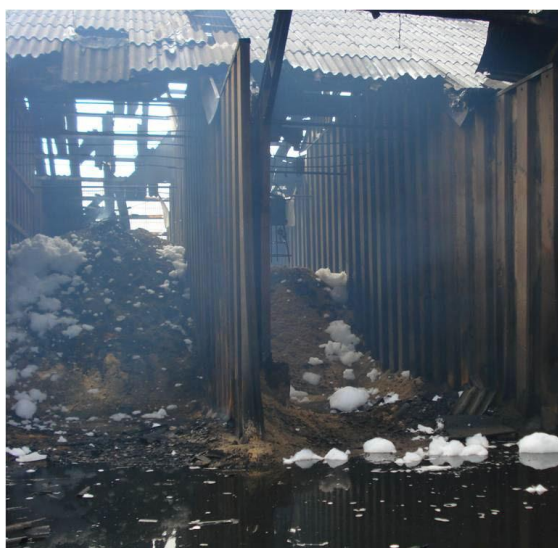
**Figure 7:** The real cause. Two of the storage bays that comprised the 500 t wood dust buffer storage. Photo courtesy of Beredskab Vesthimmerland.

Had the safety principles been applied during the investigation of the explosion in 2002, and again in 2010, attention would have been directed towards the soundness of having a buffer storage of 500 t of combustible wood dust (Fig. 7). It was convenient to store the dust, but not essential to do so. A superior design philosophy (from the point of view of safety) would be to mix raw materials according to production recipe and immediately process wood dust from the mill into pellets, eliminating the need for buffer storage, and eliminating a major source of fuel for dust explosions.

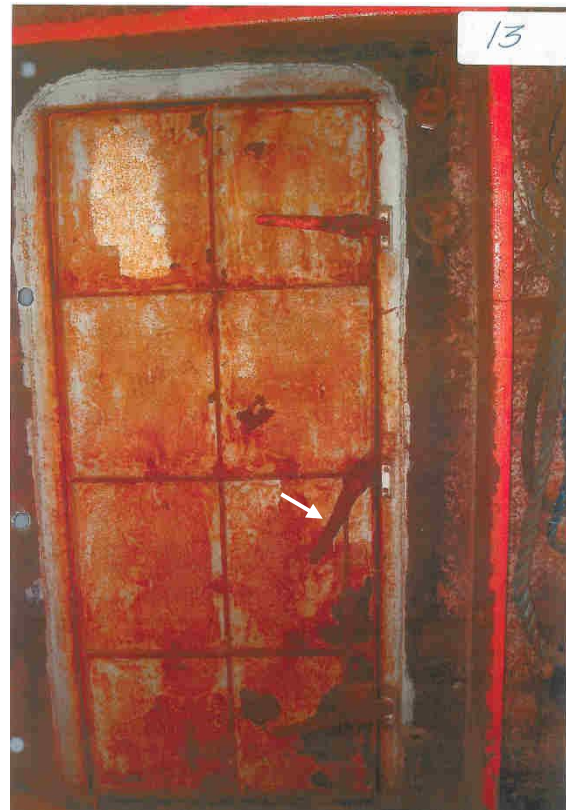
Unknown to them, poisonous carbon monoxide gasses from the cargo hold had travelled to the forepeak through a crevice in a door that separated the front cargo hold compartment and the forecastle (Fig. 8). When the seamen did not show up for dinner, a search was initiated, which found them lifeless in the forecastle.

**Figure 8:** The door in the forepeak compartment, which led the front cargo hold. The door had three closing hinges but only two were engaged. Gasses travelled from the cargo hold to the forepeak through a crevice where the third hinge (arrow) was not engaged. Source: Police investigation.
